DETERIORATION  
OF STRUCTURES IN  
SEA-WATER  
FIRST REPORT OF THE  
COMMITTEE OF THE INST. C.E.

COMMITTEE  
OF  
THE INSTITUTION OF CIVIL ENGINEERS  
APPOINTED TO INVESTIGATE  
THE DETERIORATION OF STRUCTURES  
OF TIMBER, METAL AND CONCRETE  
EXPOSED TO THE ACTION OF  
SEA-WATER

*FIRST REPORT OF THE COMMITTEE*

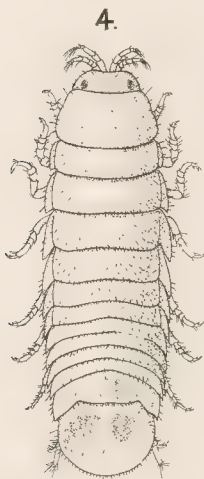
Fig. 4. *Limnoria lignorum*. From the dorsal surface. Actual length  $\frac{1}{2}$  inch.

*Limnoria* is not unlike a miniature woodlouse in appearance, see Fig. 4, p 64, and it belongs, like the woodlice, to the Order of Crustacea known as Isopoda. It measures from  $\frac{1}{8}$ th to  $\frac{1}{6}$ th of an inch in length, and has a small head and a segmented body ending in a broad tail plate. The head bears a pair of eyes, two pairs of short feelers or antennæ, and, on the under side, four pairs of jaws, including the strong mandibles with horny tips which are the organs by which boring is effected. There are seven pairs of short legs ending in sharp hooked claws, which enable the animal to cling to the surface of the wood and to move up and down in its burrow. Under the tail are five pairs of appendages each composed of two flat membranous plates which serve as gills. These gills are, in the living animal, in constant movement, causing a current which serves to renew the water needed for respiration. When out of its burrow the animal uses these plates as paddles in swimming. It possesses the power of contracting its body into the form of a ball, although not so perfectly, perhaps, as is the case with *Sphæroma*.

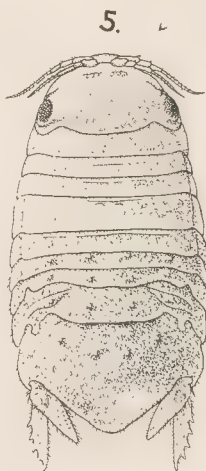
Fig. 5. *Sphaeroma terebrans*. From the dorsal surface. Actual length  $\frac{1}{2}$  inch.

The genus *Sphæroma* is closely allied to *Limnoria*, and includes a large number of species from all regions of the globe, but only a few of them have the habit of boring in timber, see Fig. 5, p. 64. One such species was described from Brazil, another from Florida, and a third from India. Stebbing (1904) regards all these as belonging to a single species, which he records also from the Cape and from Ceylon. Hedley (1901) records two other species as destroying timber in Australia and New Zealand. The question as to the identity or distinctness of the various forms can only be decided when we are able to compare, side by side, specimens from all these widely-separated localities. At all events they are very closely related, differing from *Limnoria* in a number of small characters that need not be enumerated here, but of larger size, measuring  $\frac{3}{8}$  of an inch or more in length and making burrows about  $\frac{1}{5}$  of an inch in diameter. The habit of rolling up into a ball is more marked than it is in *Limnoria*, and preserved specimens are generally found in this attitude.

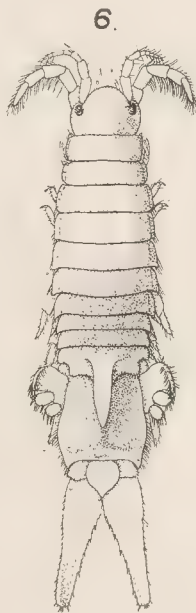
Fig. 6. *Chelura terebrans*. Male, from the dorsal surface. Actual length about  $\frac{1}{4}$  inch. The female is similar but with shorter tail-appendages and dorsal spine.

Very often on the British coasts *Limnoria* is accompanied by another wood-boring Crustacean, *Chelura terebrans*. This is a member of the Order Amphipoda, an order which includes, among many other forms, the common "Sand-hoppers." It is slightly larger than *Limnoria*, measuring  $\frac{3}{4}$ th to  $\frac{1}{4}$ th of an inch in length, and may be distinguished from it by the much larger and stronger antennae, by the pair of large tail-appendages (uropods) at the hinder end of the body, and by the sharp spine projecting from the middle of its back, see Fig. 6, p. 64.

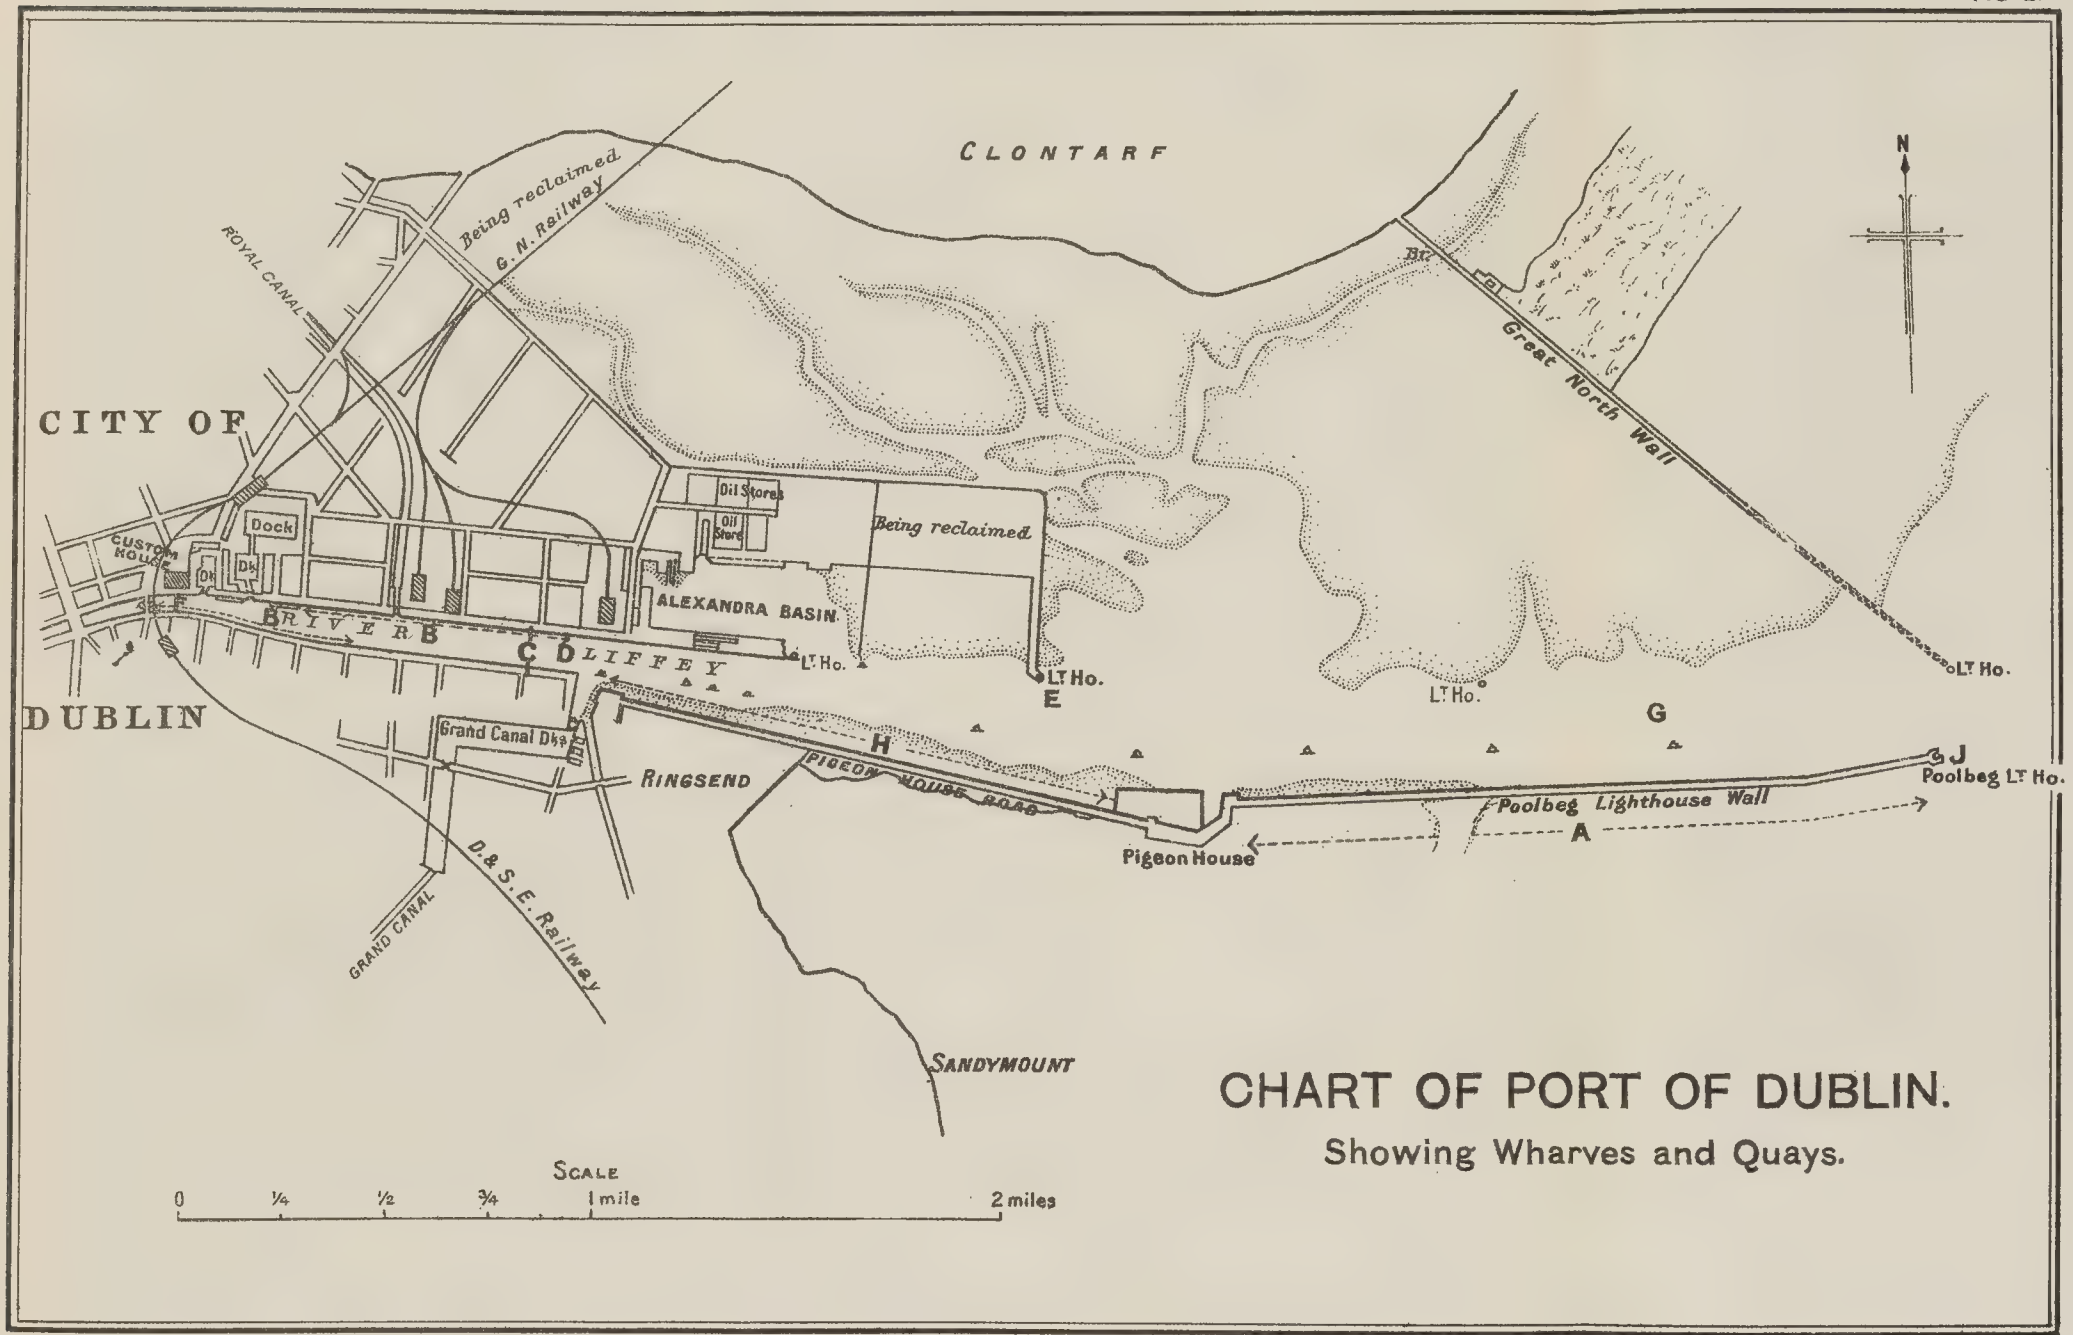
FIG. 2.

CONCRETE BLOCKS ROUND THE BASE OF POOLBEG LIGHTHOUSE.  
View from balcony of the lighthouse.

are uninjured, although laid in one of the most exposed situations in Dublin Bay.

The chart, Fig. 2, which accompanies this memorandum indicates the positions of the several works referred to therein. The photograph of the concrete blocks around the base of Poolbeg Lighthouse, Plate II., shows the present condition of the blocks.

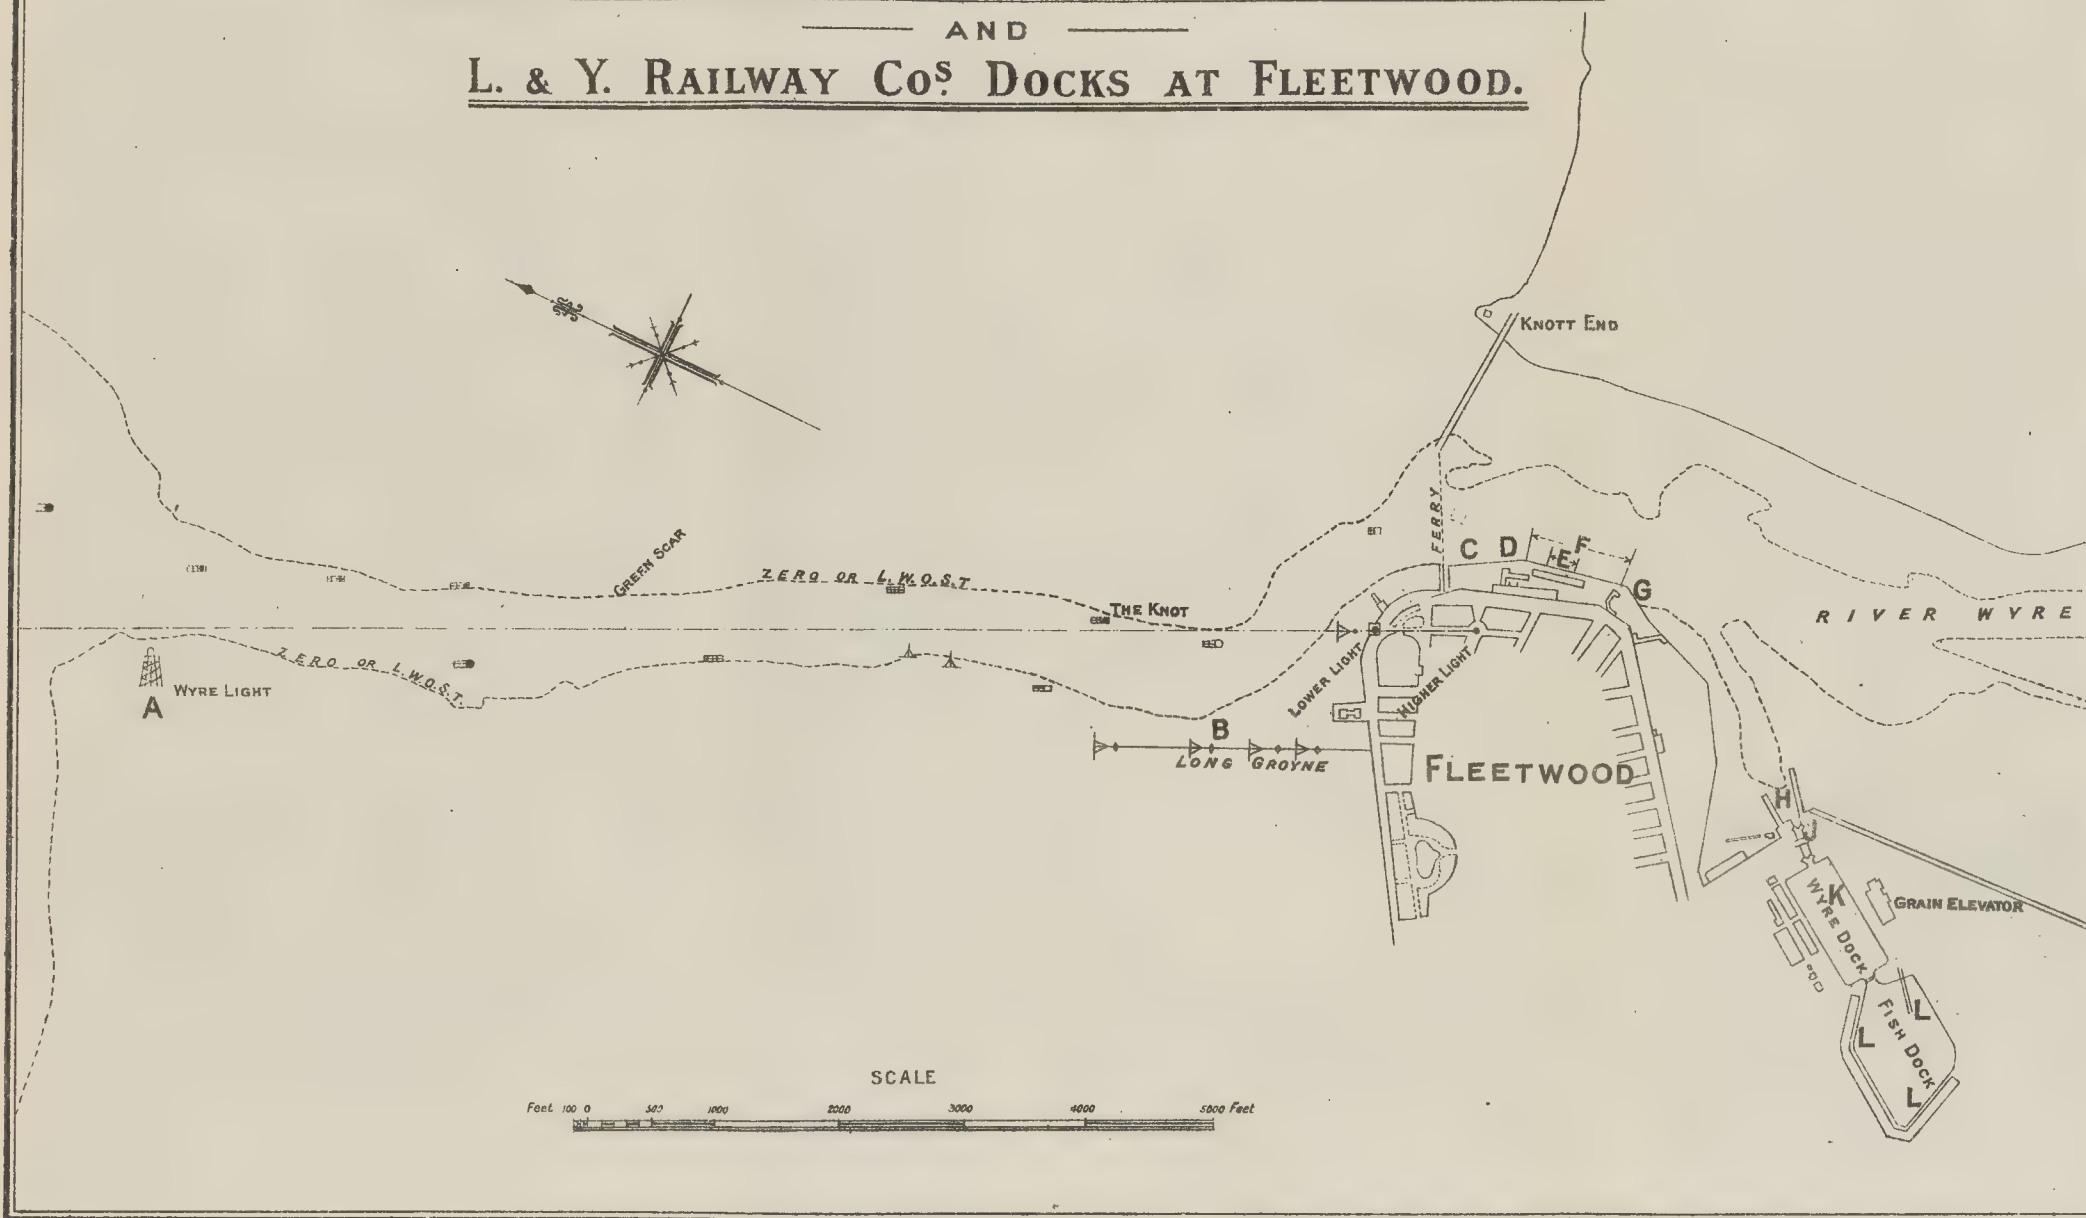
L. & Y. AND L. & N.W. JOINT RAILWAYS & HARBOUR  
 ——— AND ———  
L. & Y. RAILWAY CO<sup>S</sup> DOCKS AT FLEETWOOD.

A few of the junctions of members are affected, as described above,

more particularly those at the lower side of the front diagonal strut to trestles, and in cases where these defects have been probed the reinforcement has been found to be less than the prescribed  $1\frac{1}{2}$  inch back from the surface of the concrete. As far as can be seen, none of the piles have suffered injury through driving, nor is there any evidence of damage by the bumping of ships. The concrete throughout the reinforced structure shows no sign of deterioration.

*Protection by Waterproof Coating.*—In order to remedy these defects it was decided to coat the whole of the reinforced concrete structures, from and including the underside of deck and deck beams downwards as far as the water would permit, with one coat of tar and naphtha, in proportions of eight parts of tar to one of naphtha. This mixture formed a good skin which dried in about  $1\frac{1}{2}$  hour where the concrete was dry. Particular care was taken to fill up the pores as far as possible. This work is now in progress and the results will be reported from time to time.

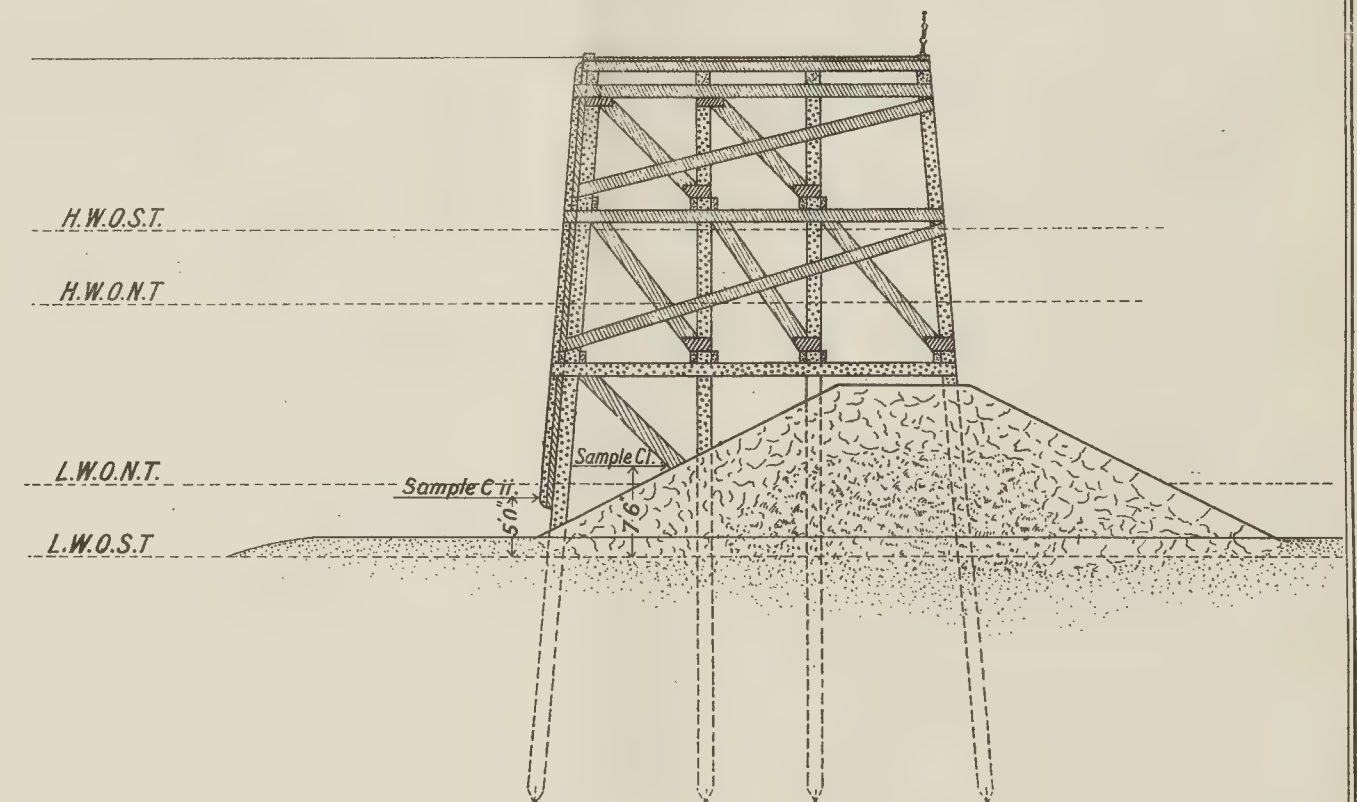
Section C - Timber Jetty

*Creosoted pitch pine.*—Two piles, 40 feet apart. One fixed 9 years, eaten to about 9 inches diameter ; and the other, fixed 10 years, shows no sign of attack.

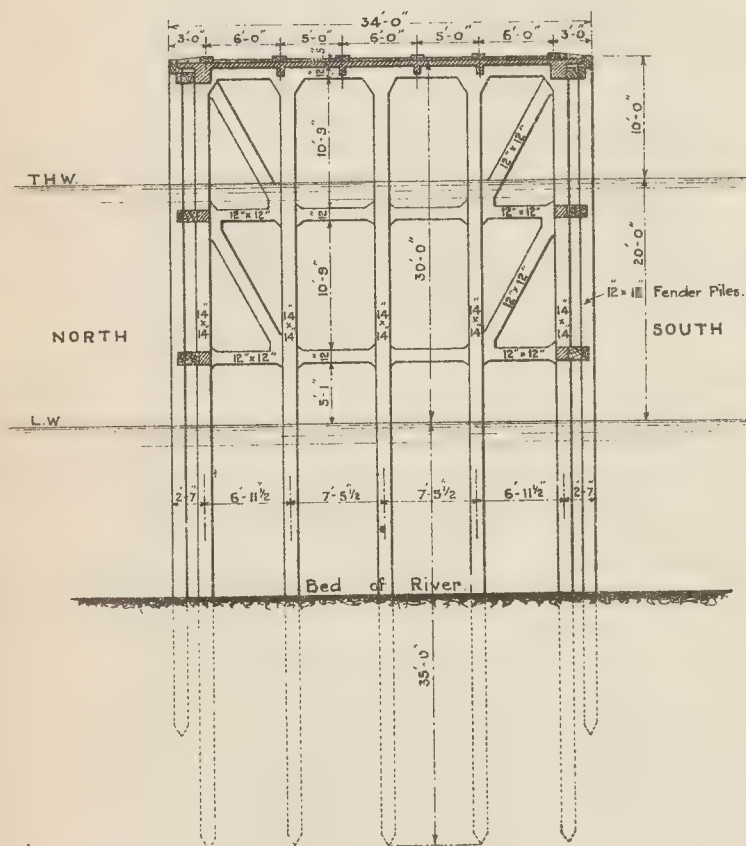
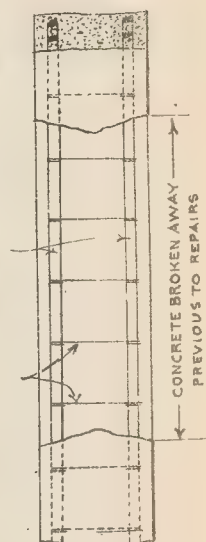
# PURFLEET PIER.

Sketch to explain mode of mending piles.

I had occasion to make an inspection of the pier recently, and I then found that nearly all the inclined struts on the south side of the pier, and in the vicinity of high-water mark, were showing signs of cracking as well as a few of the vertical and horizontal ties.

There is little doubt but that these cracks owe their origin to the racking strains brought on the pier members when vessels come up against the pier in the process of being berthed alongside. When once the crack is started water or moisture gains access to the steel reinforcing bars, causing them to corrode, forcing the concrete away from the bars, and so permitting the water to get at the steel, thus accentuating the evil.

"It is interesting to follow out these repairs, and I think the cause of the cracks is the bad design of the original links used, as it was very difficult to get them tight on the bars. We have found these slack links on every pile we have cut open and have replaced them with a new type of link. Of course, the location of these links depends on the workmen, and I regret to say they are often found out of place.

The method employed in carrying out the repairs to the affected members are well described in Mr. Anderson's reports, supplemented by the sketch, see illustration.

"Our present method of repair is to cut out the whole portion of the pile or beam affected, to clean thoroughly the steel and replace any defective links we may come across. Well ram in concrete ( $1\frac{1}{2}$  sand to 1 cement) (no cement grout used), and in a day or two when the shuttering is taken down we give the concrete a good float over with a wooden float.

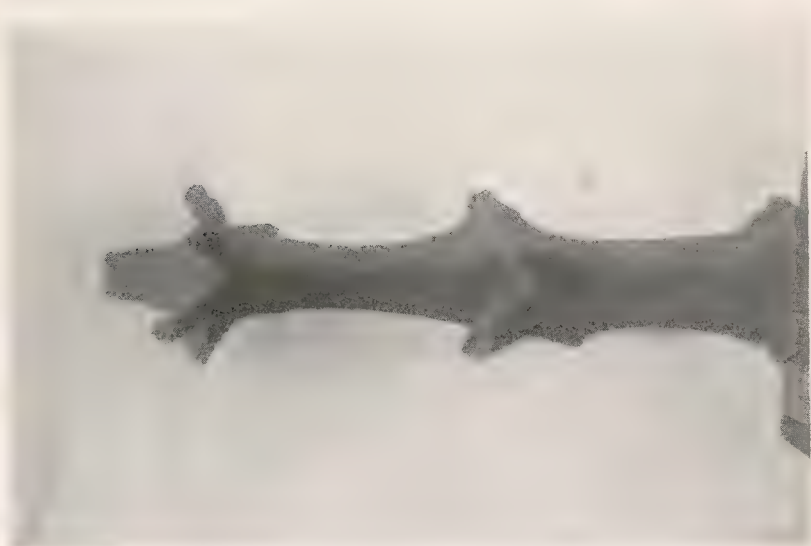
MEMEL LOG WHICH WAS PROBABLY UNCREOSOTED.

In this case the borers have eaten everything except the knots, or branches, which are only very slightly eaten, apparently because they were too hard for them.

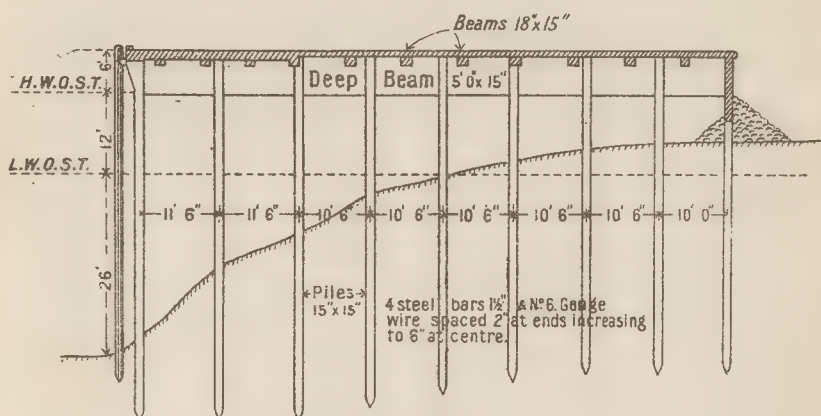
FIG. 23.

Sections C and D, built in 1914 and 1915 respectively with piles, each 18 inches by 18 inches, show so far no defects. In sections A and B the  $1\frac{1}{2}$ -inch steel bars had  $1\frac{1}{2}$ -inch cover of concrete; in sections C and D there were 2 inches of cover. The corrosion in the pile steel occurs from the lower edge of the deep beam, down to about high-water level, at the

corners. In the worst cases a "splinter" of concrete, about 12 inches long, has become cracked, more or less, but few piles show more than slight cracks a few inches long at one or two corners. The diagram illustrates the details of construction, see Fig. 23.

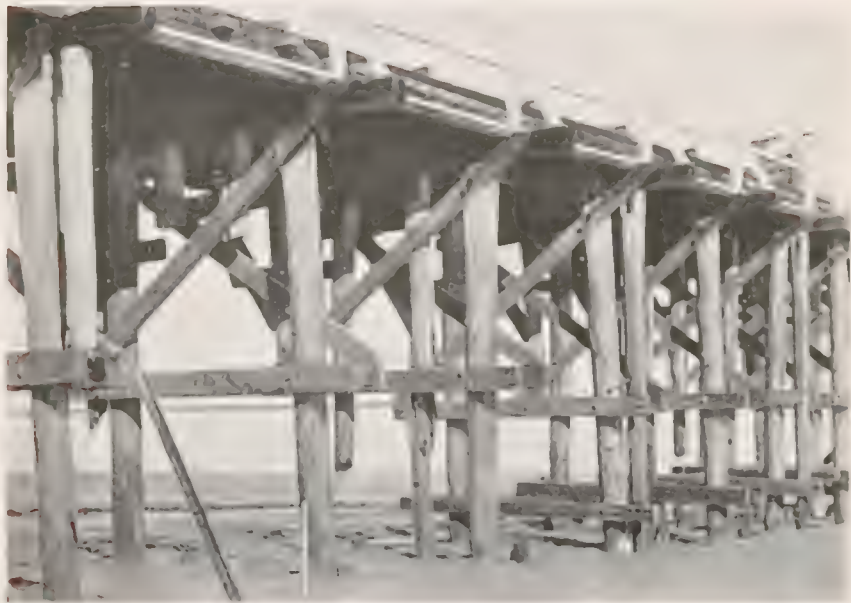
JETTY AT DERBY, WEST AUSTRALIA.

Showing piles destroyed by teredo.

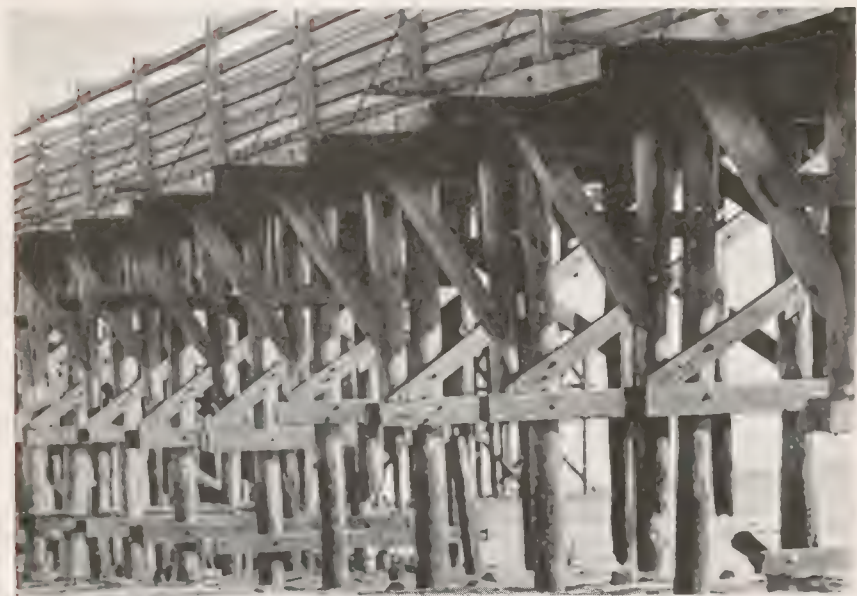
JETTY AT DERBY, WEST AUSTRALIA.

Showing piles destroyed by teredo.

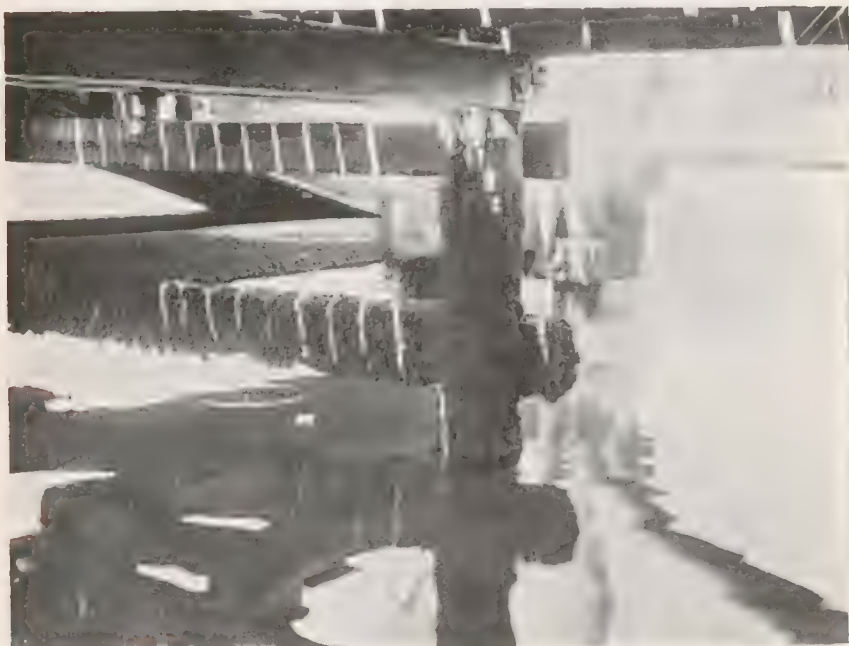
ALEXANDRIA ST. FERRY WHARF, LANE COVE. 28 years old.  
Turpentine piles and walings showing evidence of attack by teredo and limnoria.

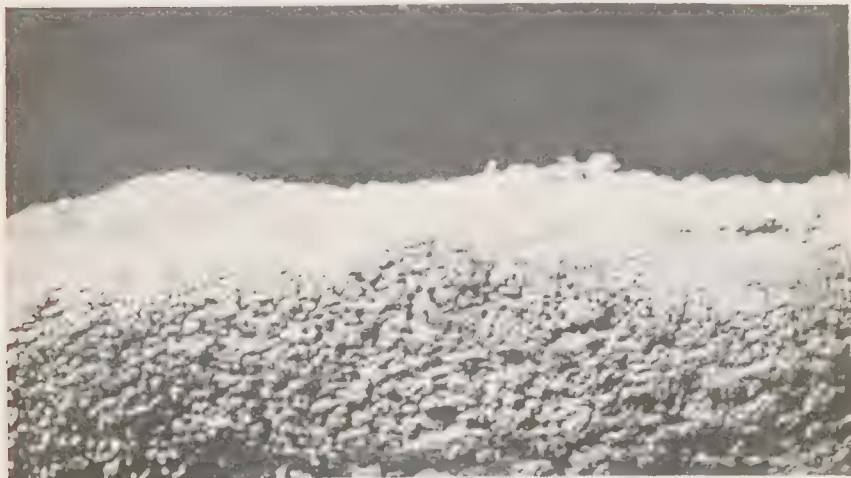
FIG TREE FERRY WHARF, LANE COVE. Over 25 years old.  
Near view of turpentine waling of landing stage showing ravages of teredo.

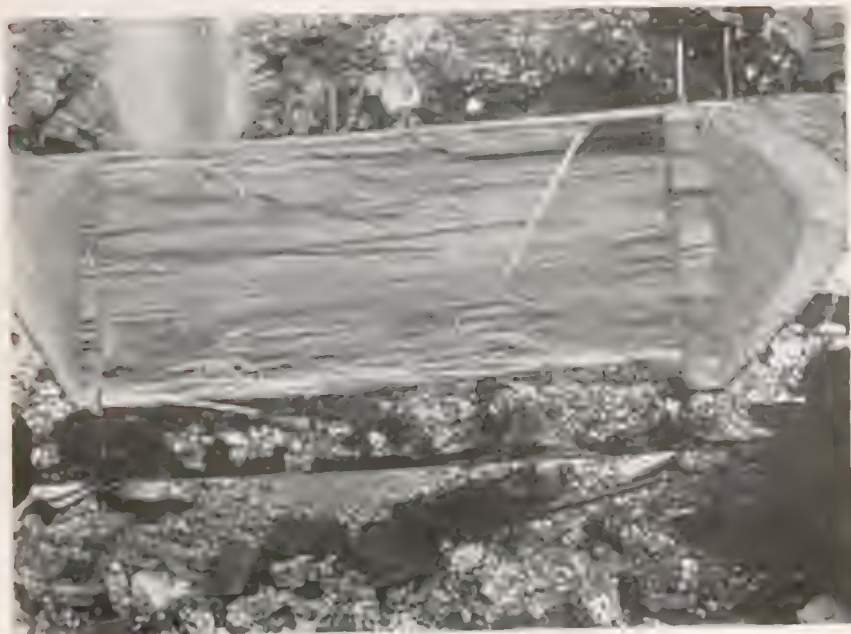
CHARRING TEST, WATSON'S BAY. 2 years 4 months old.

Near view of notch cut in upper end of ironbark pile. Note teredo holes marked by splinters in upper right-hand corner.

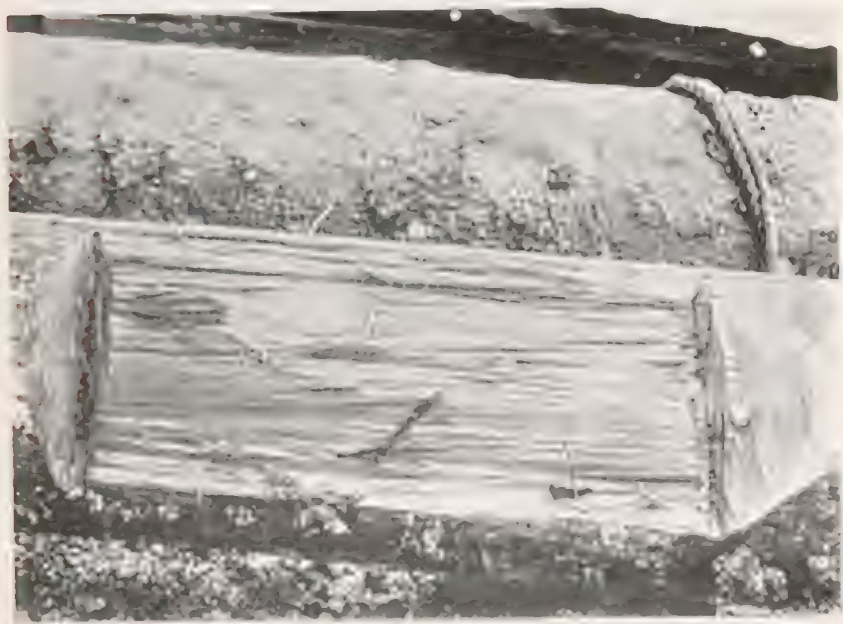
CHARRING TEST, WATSON'S BAY. 2 years 4 months old.

Near view of notch cut in centre of ironbark pile. No evidence of teredo action.

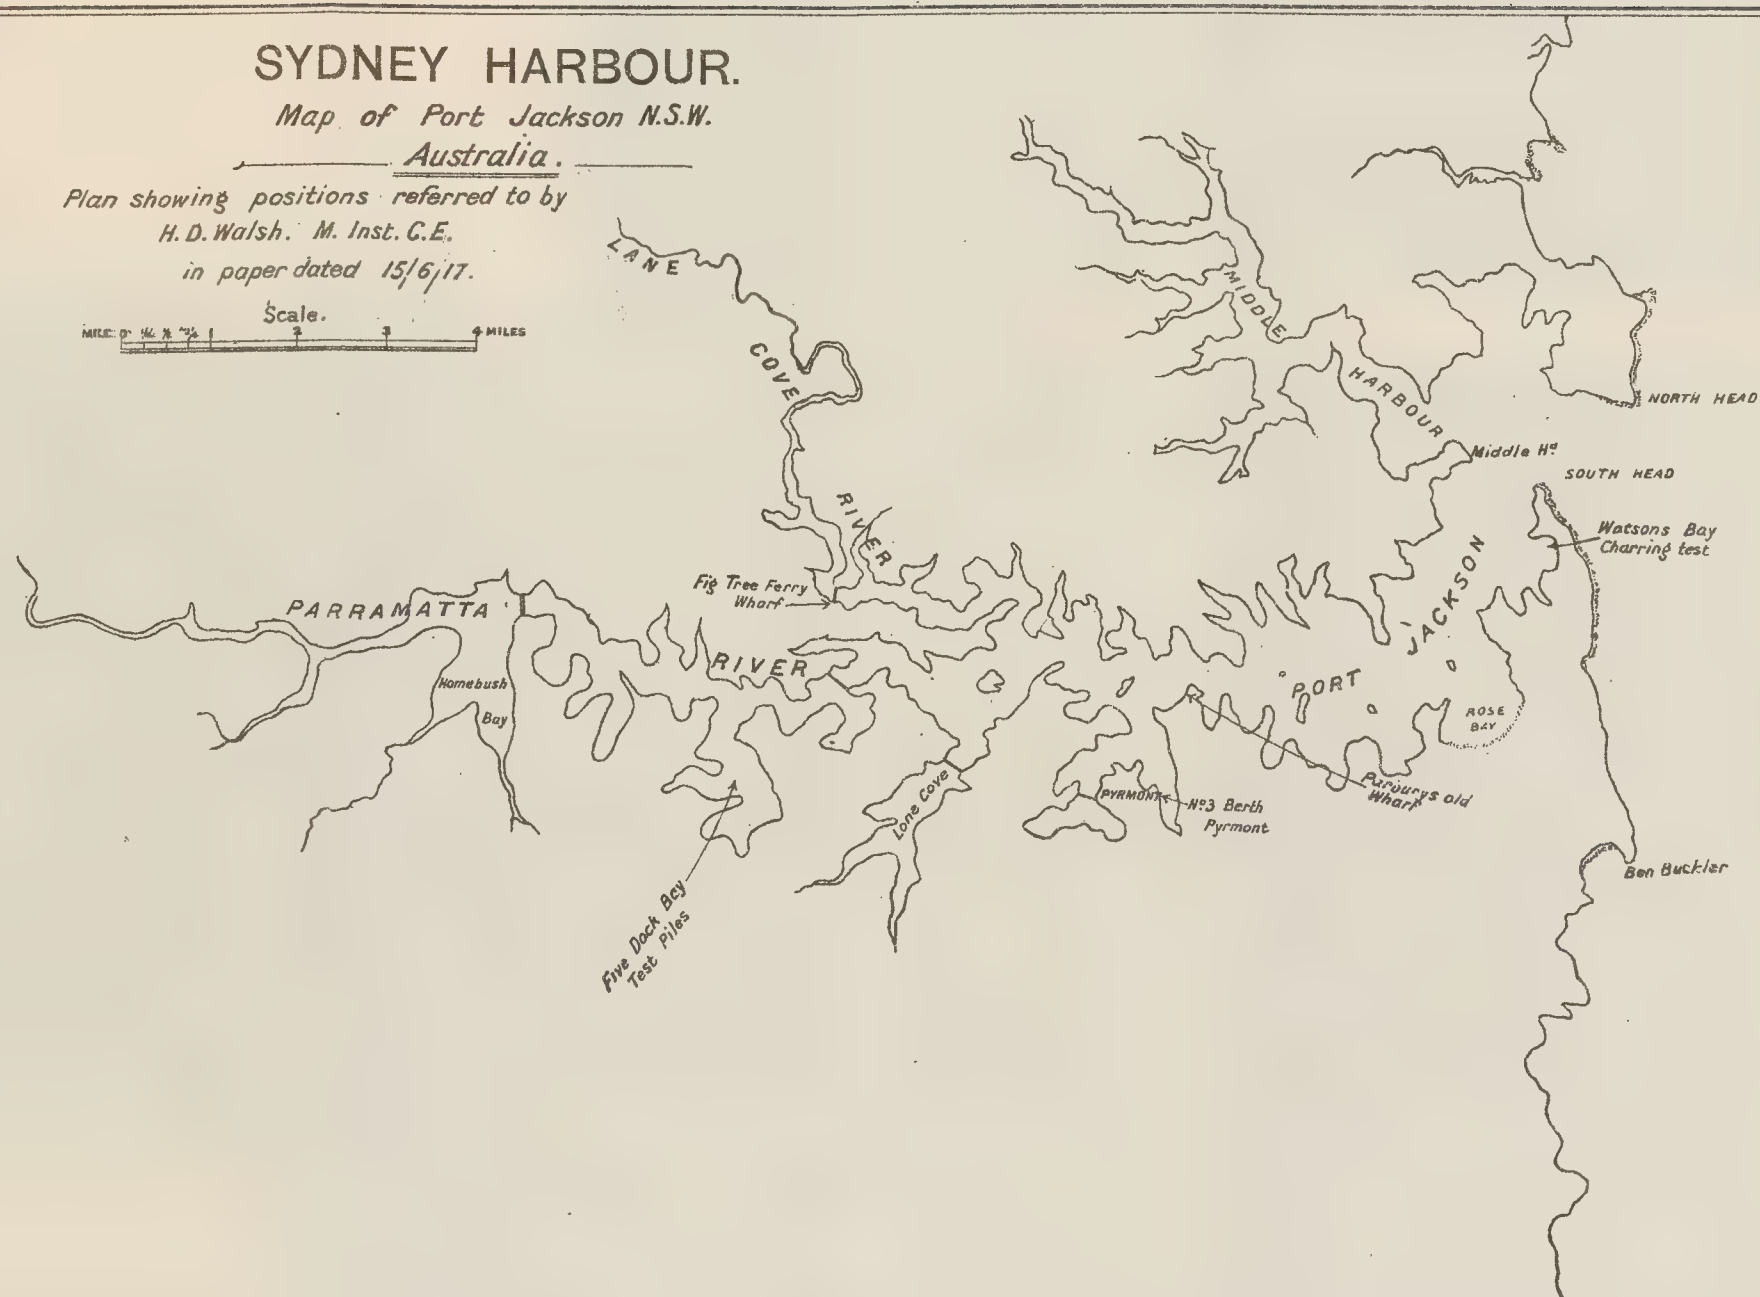
FIG. 26.

*Sewer Outfalls.*—Sewer outfalls now being diverted have hitherto discharged where shown on plan, see Fig. 26. An investigation of the timbers round about these outfalls did not show material difference in their destruction by marine pests. The volume of pollution was never great, and the dilution was large. The only fresh water entering the harbour is from storm-water overflows and natural surface drainage. This harbour is entirely an estuary, and the fresh water dilution is almost negligible.

The plan of the harbour sent herewith gives dates of construction and demolition of various timber wharves, together with positions of sewer outfalls, see Fig. 26.

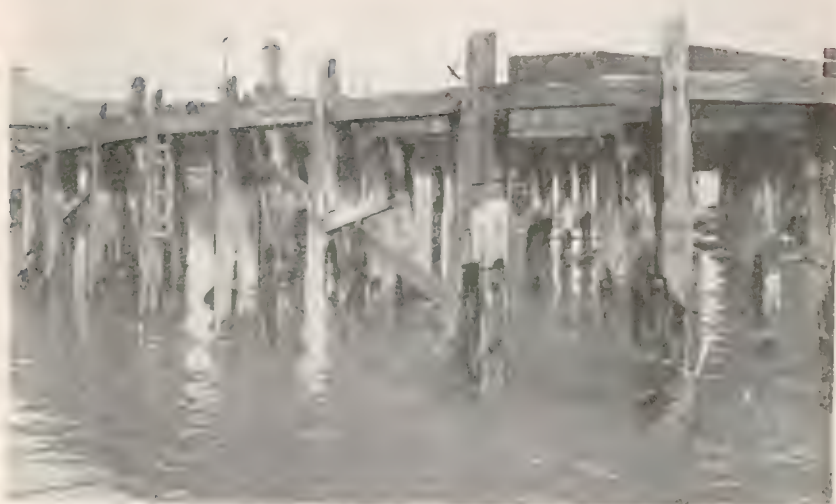
Quay Street Jetty built in 1896. All piles of Totara. Tide Gauge showing limits of destruction. Heights are above extreme L.W.S.T.

DEMOLITION OF NO. 3 QUAY STREET JETTY, FEBRUARY, 1917.

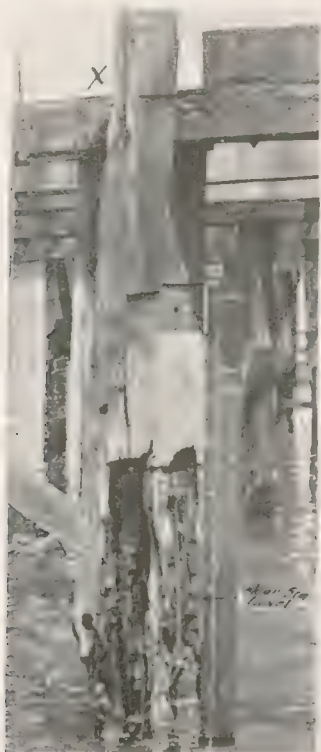
Enlargement of Pile shown in above photo.

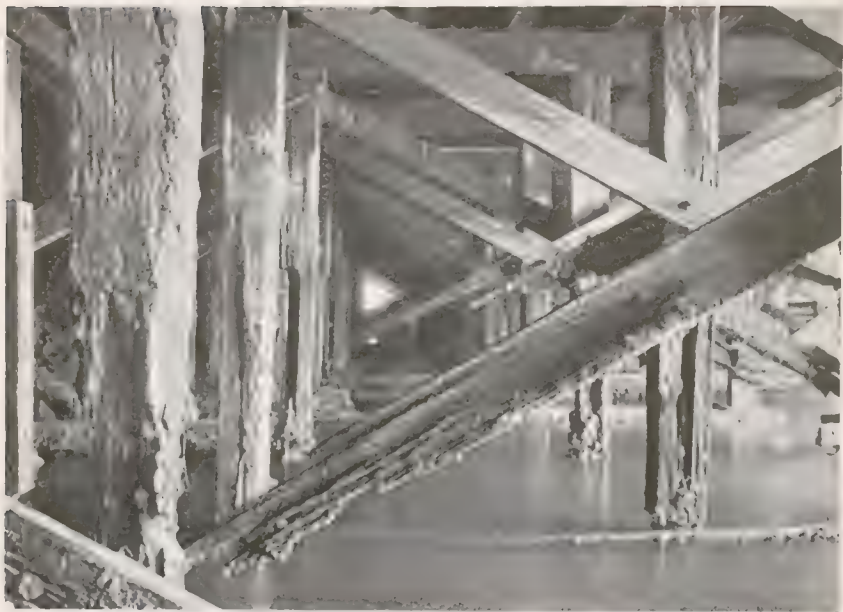
Totara piles, braces, etc., at Hobson's Wharf destroyed by *Limnoria lignorum*. Some piles wholly gone, and fish pieces placed both sides as shown in photograph. This wharf was constructed in 1881. Water level, about 3 ft. above L.W.S.T.

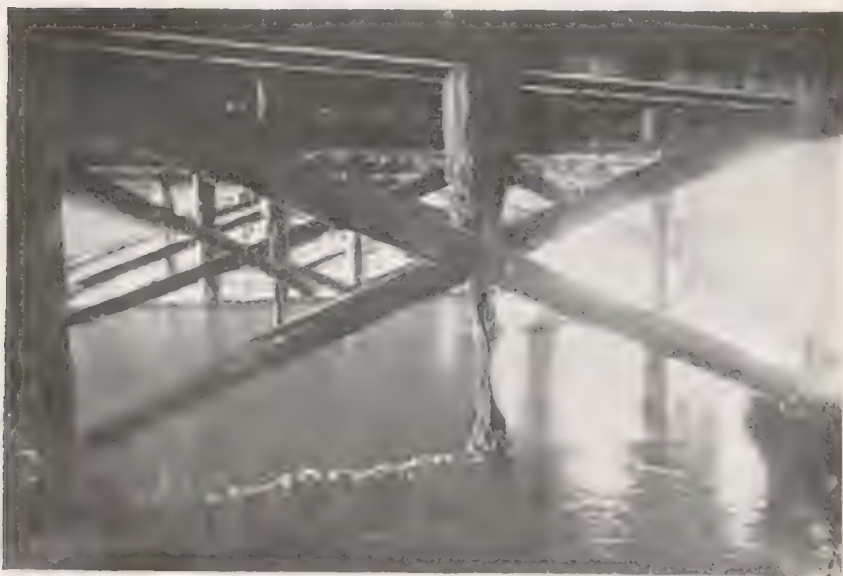
Timber under old railway wharf. Showing destruction by *Limnoria lignorum* and *Chelura terebrans*. This wharf was built 1876. Demolished 1907.

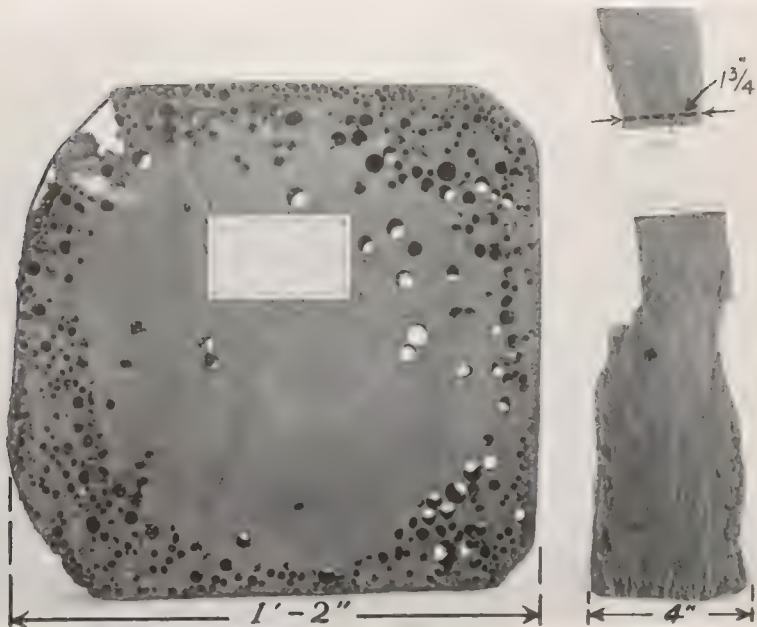
Section of Totara pile after 27 years' immersion.

Totara almost destroyed by *Chelura*.

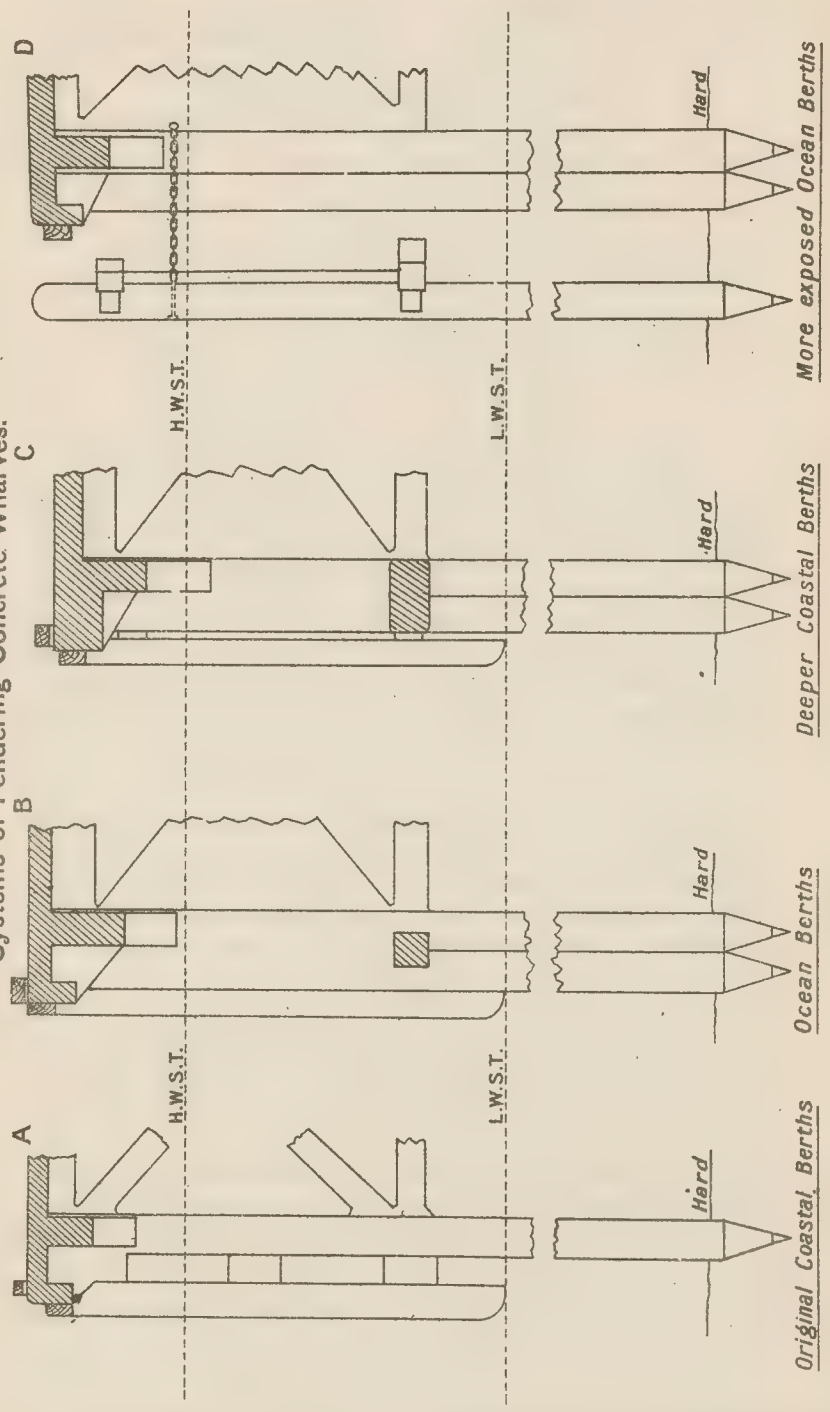
Systems of Fendering Concrete Wharves.

*Damage by Bumping of Ships.*—The outside piles of wharves were originally protected by timber fenders extending to L.W.S.T., bolted directly on to the concrete pile face or packed out where there were single front piles. Occasionally a ship falling heavily against these fenders would flake off a spawl of concrete on one or both sides of the front pile at the level where it struck. This would be about the size of one's hand, tapering from a thickness of 1 inch to *nil*. This refers particularly to local coasting vessels, which have beltings around their hulls, but the total of all such damage has been small.

Subsequently the solid fenders were packed off the face of the pile about 2 inches to allow of some spring between deck level and low-water, and this acted well. Finally spring fender piles of full length were substituted in some ocean berths for the previous fenders to L.W. only, and no damage has since occurred, see Fig. 30.

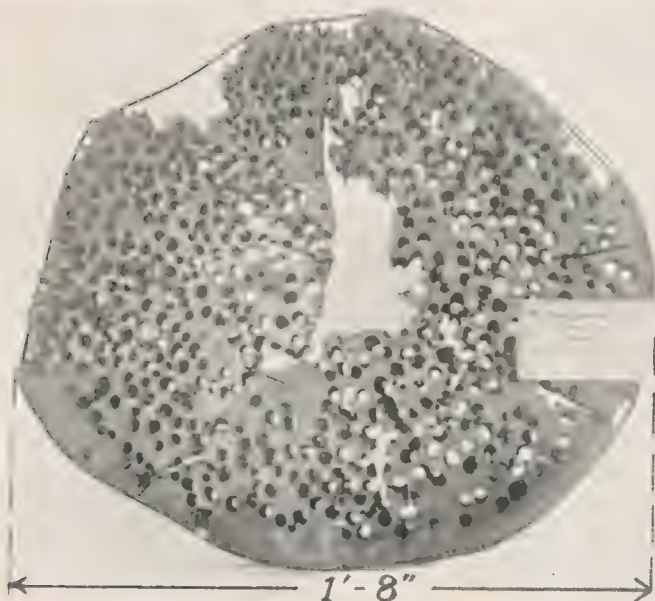
Section of Pile of Blue Gum (*Eucalyptus globulus*) from Old Queen Street Wharf,  
after about 27 years' immersion.

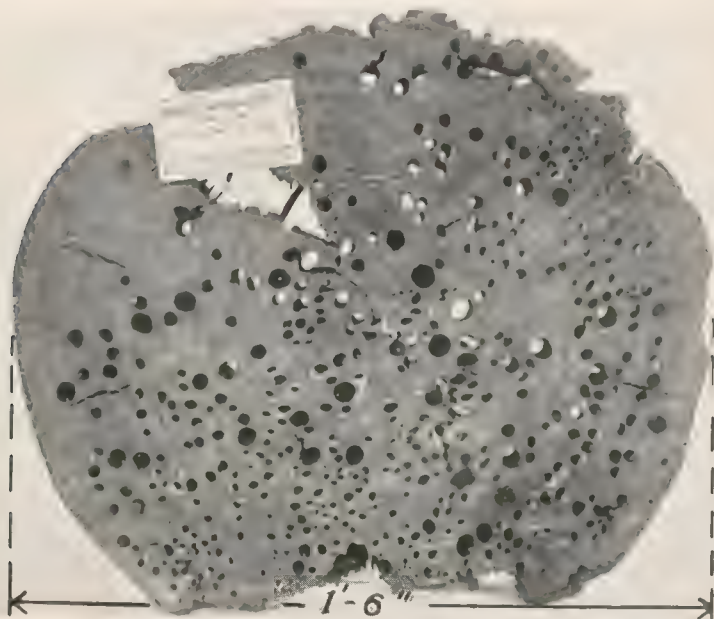
Section of Pile of Blackbutt (*E. pilularis*) from Old Queen Street Wharf,  
in use about 27 years.

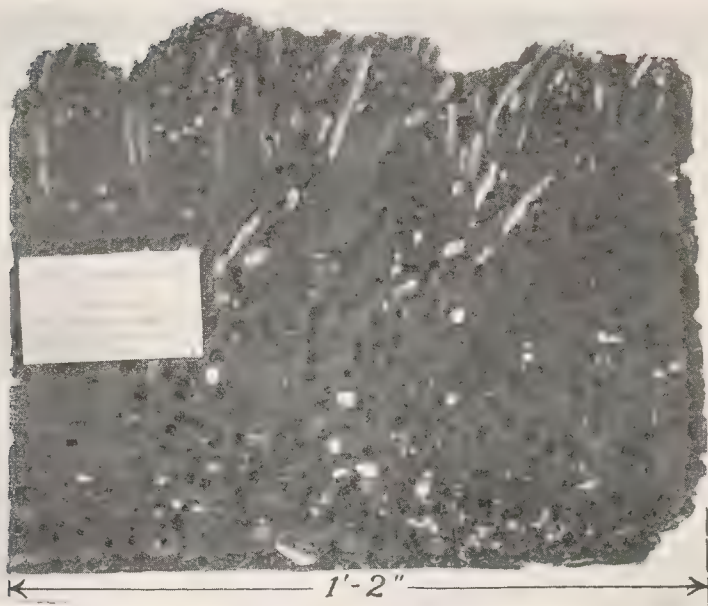
Specimen of Jarrah (*Eucalyptus marginata*) from Birkenhead Wharf, after being in use about 3 years.

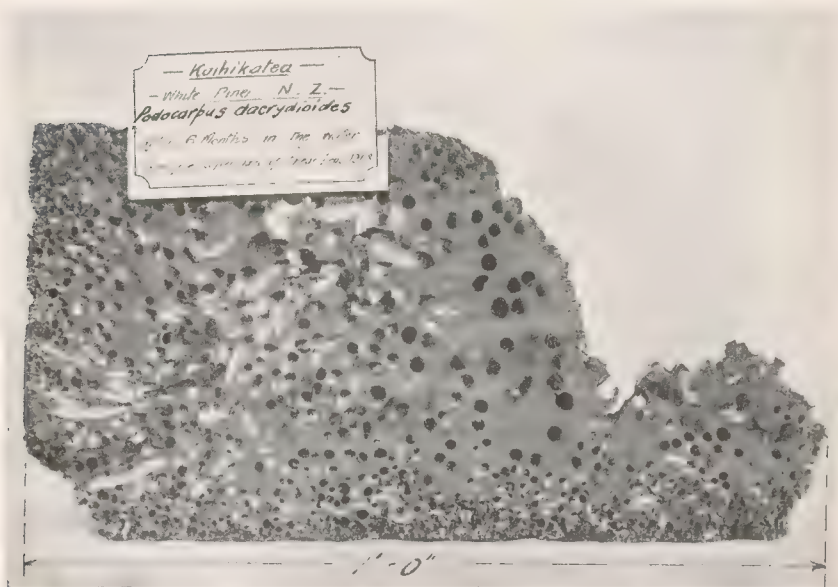
Specimen of Kaihikatea, after 6 months in the water, from coffer dam of Shear Legs, 1903.

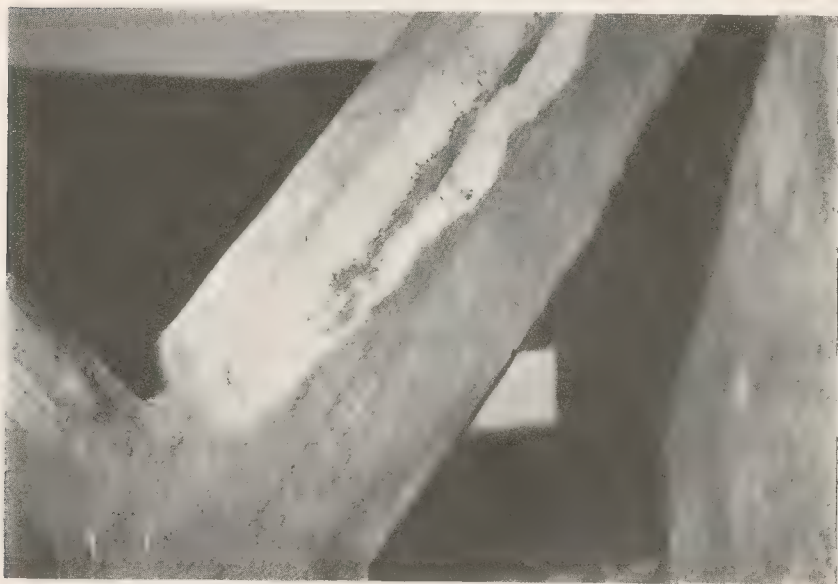
Longitudinal strut under outside beam in 3rd bay from outer end of wharf on east side. In position 8 years. Centre of damage to concrete about 1 foot 6 inches above H.W.O.S.T.

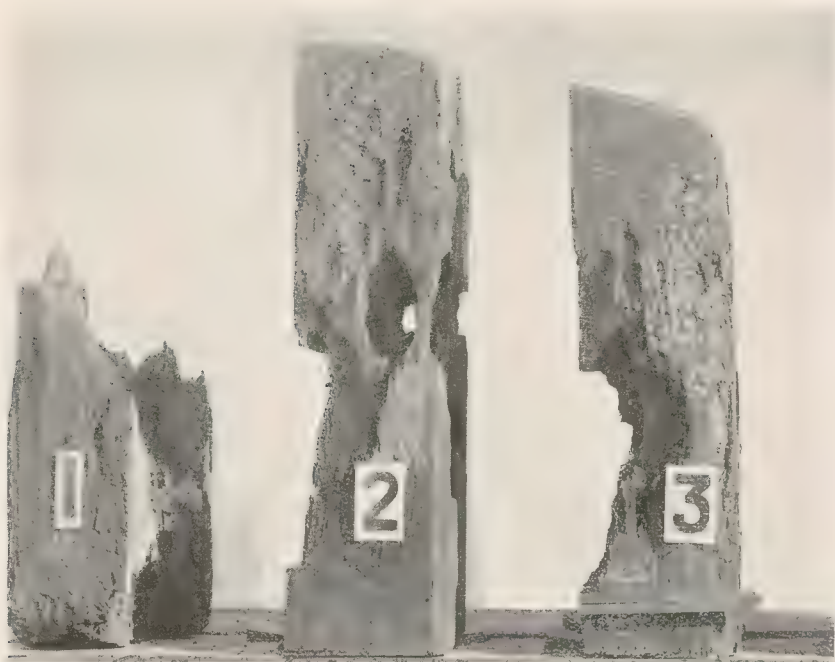
View No. 1.

SPECIMENS OF WORM-EATEN TEAK.
